# APOLLO

Auto Visual Monitoring – a pilot program with collaboration between the City of Buckeye Public Works and the Arizona Department of Environmental Quality

FY18 Permit Cycle – July 1, 2017 through June 30, 2018

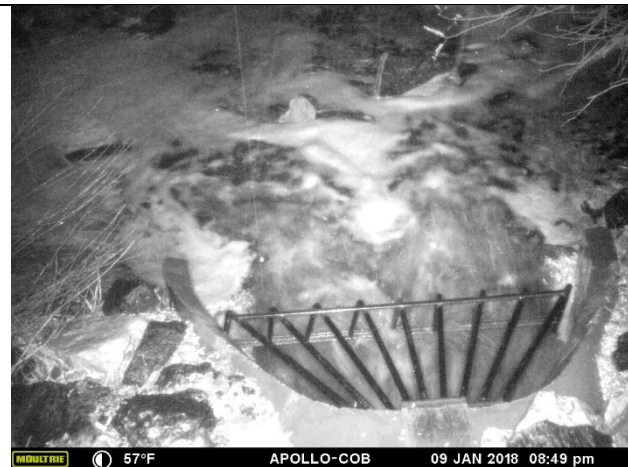
57°F APOLLO-COB 09 JAN 2018 08:49 pm

First full rain event capture – January 9, 2018

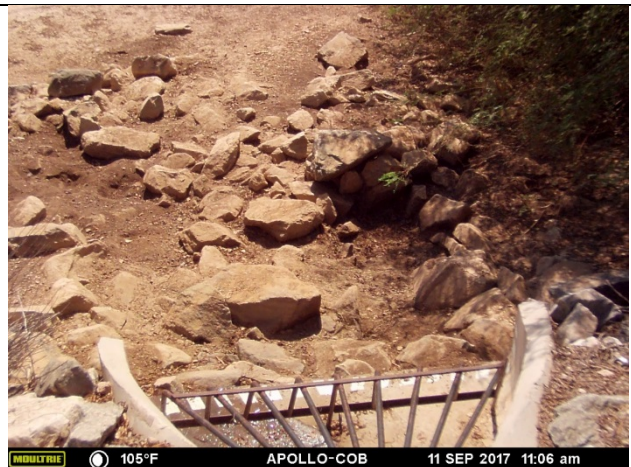
105°F APOLLO-COB 11 SEP 2017 11:06 am

Normal irrigation flow observed – volume too low to measure

In summary, the daily water discharge to this outlet during non-rain events was found to be from the neighborhood irrigation system of individual homes and common areas of the development, as well as occasional washing of personal vehicles. This type of runoff rarely exceeded 15' past at the end of the outlet and did not contribute flow into the wash.

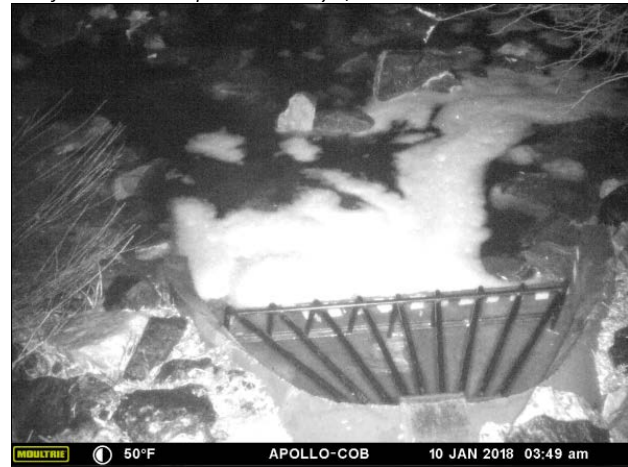
50°F APOLLO-COB 10 JAN 2018 03:49 am

Foam observed during rainfall - January

Foam of unknown origin and content (seen in Figure 9) was observed during several rain events, and would not have been observed without this camera capturing live flow. It is common knowledge that possible sources of foam could include organic detritus from heavily watered and maintained lawns and flower beds.

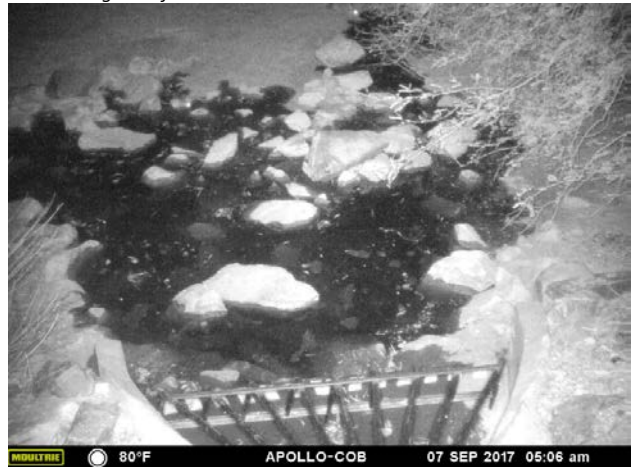
80°F APOLLO-COB 07 SEP 2017 05:06 am

Normal irrigation flow to the 10' mark

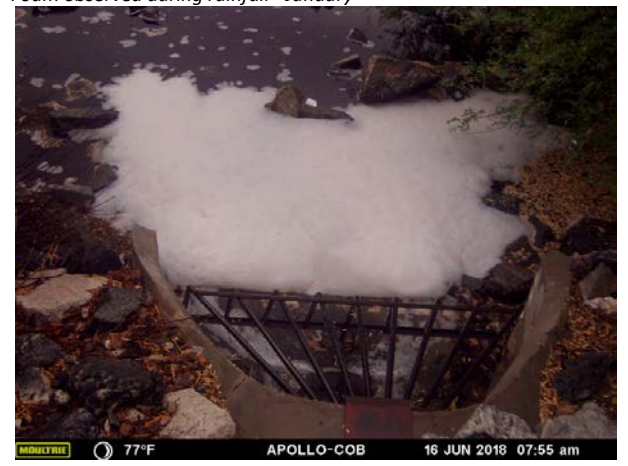
77°F APOLLO-COB 16 JUN 2018 07:55 am

Foam observed during rainfall – June
