ANNUAL REPORT

Arizona Pollutant Discharge Elimination System (AZPDES) Small Municipal Separate Storm Sewer System (MS4) General Permit (AZG2016-002)

Annual Report for Reporting Year: 2017-2018

Auto Visual Monitoring – a pilot program with collaboration between the City of Buckeye Public Works and the Arizona Department of Environmental Quality

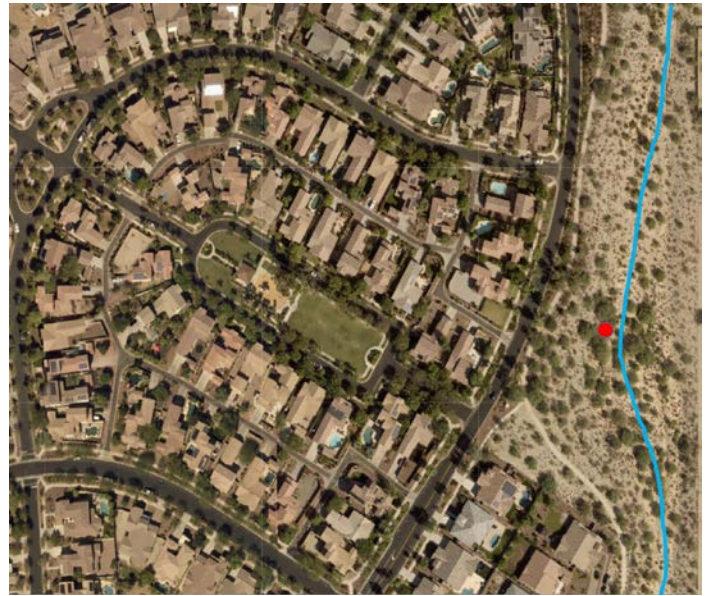
Figure 3

The City of Buckeye and the State of Arizona chose the Tuthill/Acacia/Osborn Road Wash (the wash) within the Verrado neighborhood as its monitoring location (see Figure 3).

The watershed, outfall (see red dot on Figure 3), and the wash (see blue line on Figure 3) are a general representation of 10 similar features within this large subdivision along the two mile stretch of Acacia Road located adjacent to the wash. All ten outfalls were scrutinized for this project and all had negative constraints ranging from being too close to homes and pedestrian walkways, to over-vegetated areas, or vegetation that was too large, or difficulty in access to the outfall. This location (see Figure 4) was decided due to its ease of access, direct discharge to a wash¹, low profile area, significant low brush vegetation masking visibility from neighboring properties, and distance from pedestrian walkways. Additionally, this location had safe street parking, as frequent site visits were important to retrieve data and monitor equipment status.

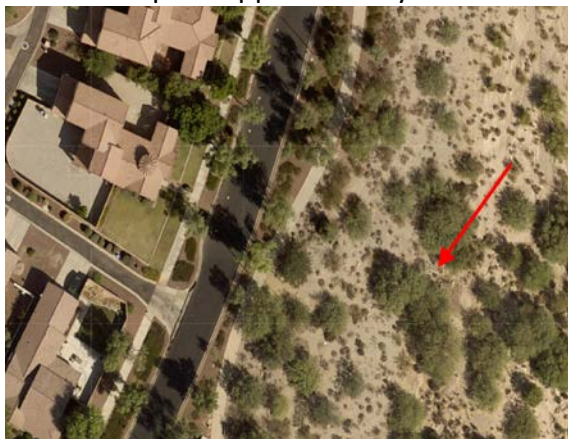
Figure 4

The monitoring area is located at the central portion of the Verrado community near the intersection of N. Acacia Way and W. Springfield Street, just south of Indian School Road. The outfall empties approximately 25' above the high water mark of the wash. The watershed seen in Figure 3 spans approximately 15 residential acres containing nearly three miles of curb and gutter.

During FY18, confirmation of the wash, regional drainage flows, and collaboration with the Flood Control District of Maricopa County, proved that this area was not, by definition, an outfall as it did not discharge to a Water of the United States (WOTUS) directly, nor was it a tributary to a WOTUS. From this point forward this discharge point will be referred to as an outlet, not an outfall².

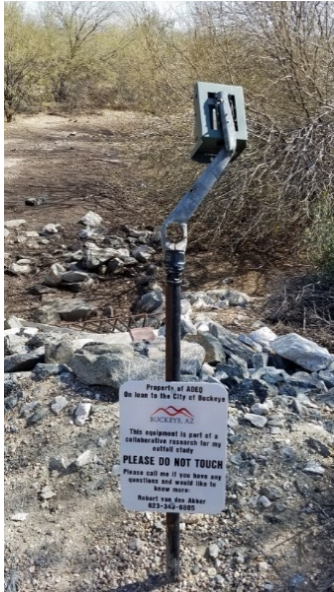
Figure 8

The City used a 16 MP SD card to store images. Images were downloaded onto a permanent server which allowed for adequate review and documentation. The camera photo capture settings were increased prior to rain events down to 30-minute intervals. Photos were captured more frequently during forecasted rain event periods in order to attempt to capture the first flush and subsequent visual flow activities.

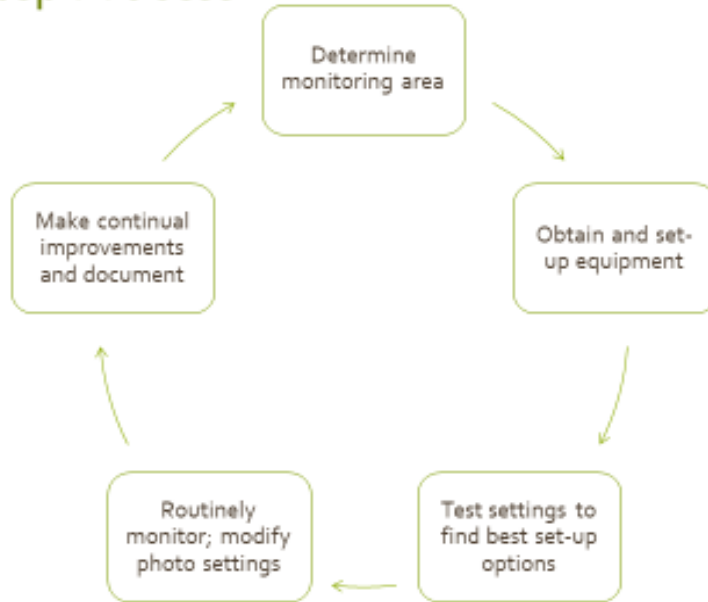
Figure 11

- Qualitative analysis of flows (light or heavy flow)
- Observable flows
- Bulk material/trash deposits
- Irrigation flow documentation
- Identify areas of erosion
- Wildlife sightings
- Varmint identification (Figures 9 and 12)
- Monitoring areas difficult or costly to access
- Wonderful collaboration project opportunity with ADEQ and a municipality
- Development of an auto monitoring process for outfalls (Figure 11)

Easy 5-Step Process
